**Asbestos Refurbishment/Demolition Survey for**  
Worcester Norton Sports Club Ltd

Worcester Norton Sports Club  
Norton Barracks  
Brockhill Lane  
Worcester  
WR5 2PP

Project Number: D0082

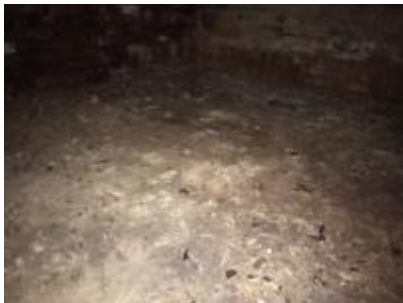
Location Ref: 002

Product Type: Asbestos cement

Damage: High damage

Remove

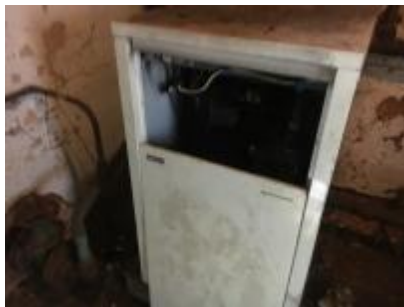
Ropes and woven textiles

No visible damage

Remove

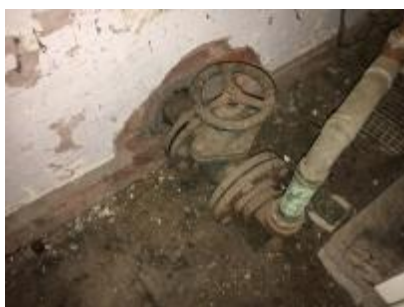
Gaskets

No visible damage

Monitor & Manage; Unless Works  
Require Removal

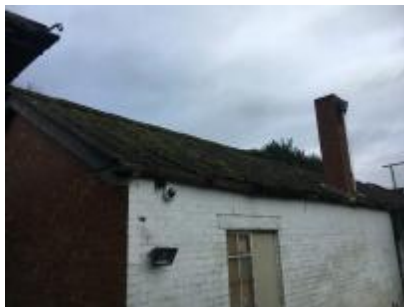
Location Ref: 031

| Location | Product type and name | | Extent | Accessibility | Condition | Surface treatment | Asbestos Type | Sample | Sample no | Material Risk Score | Priority Risk Score | Total Score |
|---|---|---|---|---|---|---|---|---|---|---|---|---|
| Main Building, Roof, External | Asbestos cement | Cement | 500m <sup>2</sup> | Medium Accessibility | Low damage | Asbestos cement sheets etc | Chrysotile | Identified | 031 | 4 | | N/A |

Product Type: Asbestos cement

Damage: Low damage

Remove

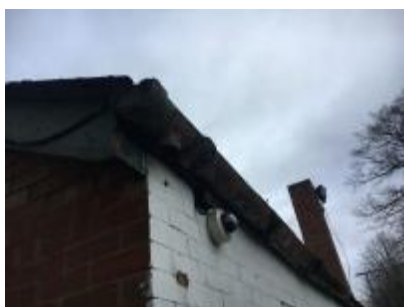
Location Ref: 032

| Location | Product type and name | | Extent | Accessibility | Condition | Surface treatment | Asbestos Type | Sample | Sample no | Material Risk Score | Priority Risk Score | Total Score |
|---|---|---|---|---|---|---|---|---|---|---|---|---|
| Main Building, Roof, External | Asbestos cement | Cement | 80 lm | Medium Accessibility | Low damage | Asbestos cement sheets etc | Chrysotile | Identified | 032 | 4 | | N/A |

Product Type: Asbestos cement

Damage: Low damage

Remove

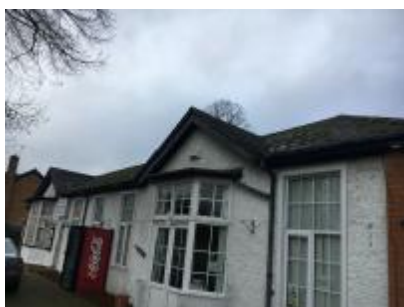
Location Ref: 033

| Location | Product type and name | | Extent | Accessibility | Condition | Surface treatment | Asbestos Type | Sample | Sample no | Material Risk Score | Priority Risk Score | Total Score |
|---|---|---|---|---|---|---|---|---|---|---|---|---|
| Main Building, Roof, External | Asbestos cement | Cement | 700m <sup>2</sup> | Difficult Accessibility | Low damage | Asbestos cement sheets etc | Chrysotile | Identified | 033 | 4 | | N/A |

Product Type: Asbestos cement

Damage: Low damage

Monitor & Manage; Unless Works  
Require Removal

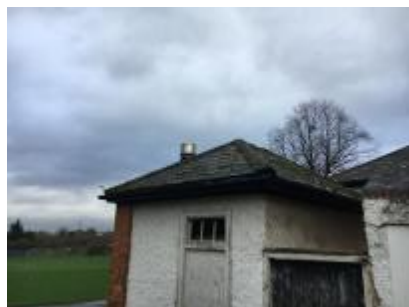
Asbestos cement

Low damage

Monitor & Manage; Unless Works  
Require Removal
