27 November 2020

**Preliminary Roost Assessment – Worcester Norton Sports Club, Brockhill Lane,  
Norton Barracks, Worcester, WR5 2PP**

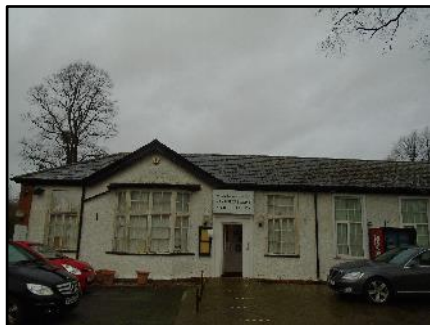
**Plate 1:** showing a typical view of the Club House. Photograph looking at south eastern elevation.

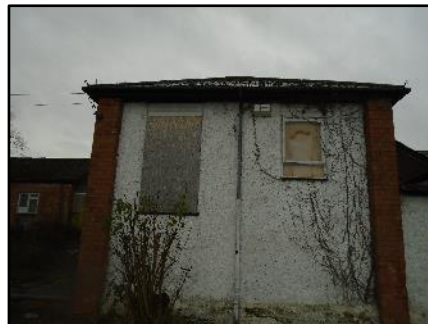
**Plate 2:** showing a typical view of the Club House. Photograph looking at northern elevation.

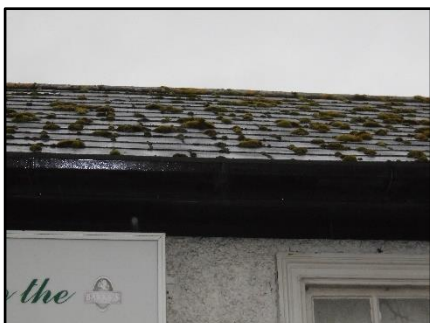
**Plate 3:** showing a typical view of the Club House roof cover.

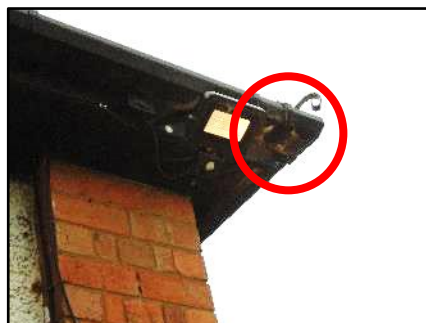
**Plate 4:** photograph showing a rotted crevice in the soffit located next to the flood light.

The general structural condition of the ‘Club House’ is good, although a crevice within the wooden soffit was noted. The gap is located at the end of the soffit and close to the security flood light. A detailed inspection of the small loft above the main section of the Club House building was not possible due to limited access. The proposal includes the cleaning of the loft void.

Taking into consideration that only internal refurbishment of the building is being proposed and a single suitable roosting feature for bats was observed (located close to the external source of light), the likelihood of bats roosting within the building is considered to be **negligible – very low** (with reference to Collins, 2016).

3. As a precautionary approach, it is recommended that a licensed ecologist directly supervises the hand removal of soffits / fascia boarding if these require replacement. The ecologist should undertake a detailed inspection of any holes within the soffit/ fascia boarding to be replaced, using an endoscope where required. The licenced ecologist should then be 'on call' during the remaining works. **In the unlikely event that roosting bats and / or evidence of roosting bats (e.g. droppings) are discovered, works must cease immediately and Natural England must be contacted to advise on any licensing requirements to allow lawful completion of the work.**
