Ref: 15<sup>th</sup> Dec 2020 - BJU/mmi

To: **Worcester Norton Sports Club.**

**Norton Barracks, Brockhill Lane, Norton, WR5 2PP.- BS5837 Tree Constraints, Tree Impacts and Tree Protection Method Statement for replacement Community Hall & Pavilion.**

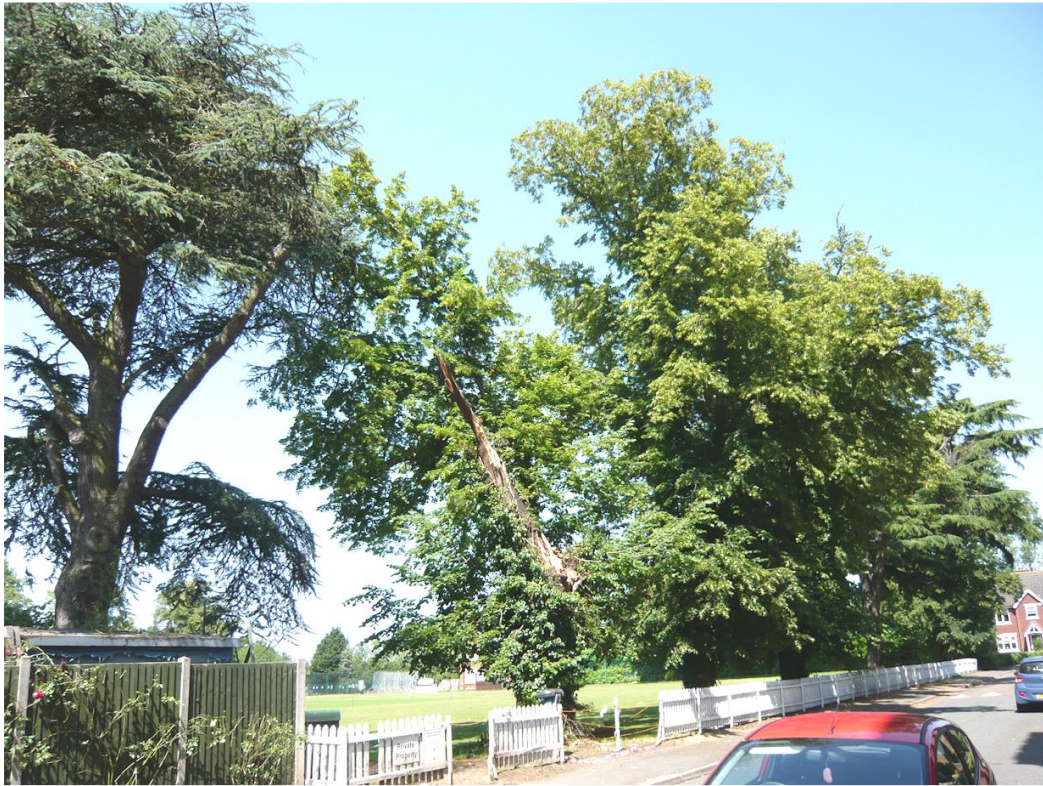
- 4.1 The dominant feature is limes edging the fields. Some may be mid-Victorian, planted when the adjacent barracks were built.
- 4.2 T2 is one such lime, with obvious basal decay, whose top broke off recently. It needs pollarding. Broken stem central in photo below.

| No.<br>T=tree<br>S= shrub<br>H= hedge<br>G= group | Species | Dbh<br>(stem diam<br>@ 1.5m<br>ht)<br>mm. | Total height. Ht to base of crown.<br>Est Ht in 10 yrs. m. | | | Crown radii m. | | | | Age class | Health | Structural Condition | SULE | Comment<br>(All are in average to good health and condition, unless stated otherwise.) | Retention category<br>A (best) to C. U = (remove)<br>Sub-category 1, 2 or 3 | BS 5837 Root Protection Area Radius. m. | Recommended WORK excluding development. |
|---|---|---|---|---|---|---|---|---|---|---|---|---|---|---|---|---|---|
| T2 | Common lime | 1000 | 15 | 5 | 6 | 7 | 0 | 0 | 7 | Lm | F | P | 20+ | Severe basal decay. Stem broke at 4m height June 2020. | C2 | 12.0 | Pollard at main fork. |

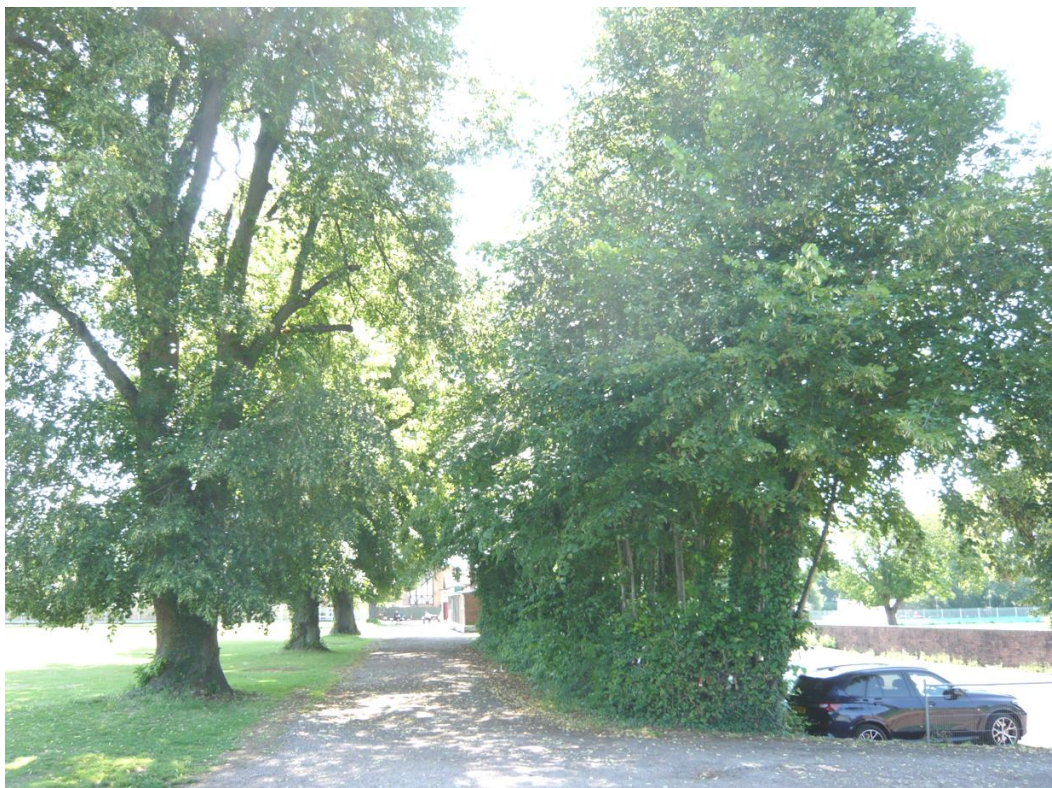
- 4.3 The row of four old limes T19-T22, opposite clubhouse or parking, are all well-shaped and large, healthy, trees. But two exhibit decay fungi spore bodies, and a fifth tree fell two years ago, with a totally-decayed base.

| T19 | Common lime | 820 | 18 | 3 | 18 | 7 | 6 | 7 | 6 | M | F | F | >40 | | A2 | 9.8 | To match other nearby limes: Heavy crown reduction down to 15m and 1/3 off radii. |

| T19 | Common lime | 9.8 | To match other nearby limes:<br>Heavy crown reduction down to 15m and<br>1/3 off radii. | <u>Crown reduce as recommended.</u> | <u>To allow for increased pedestrian access around the trees.</u> |

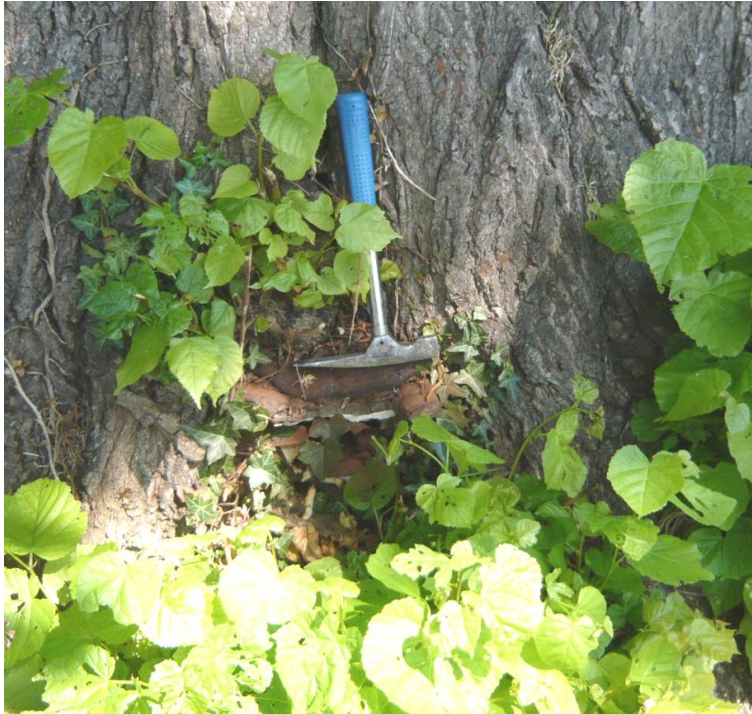
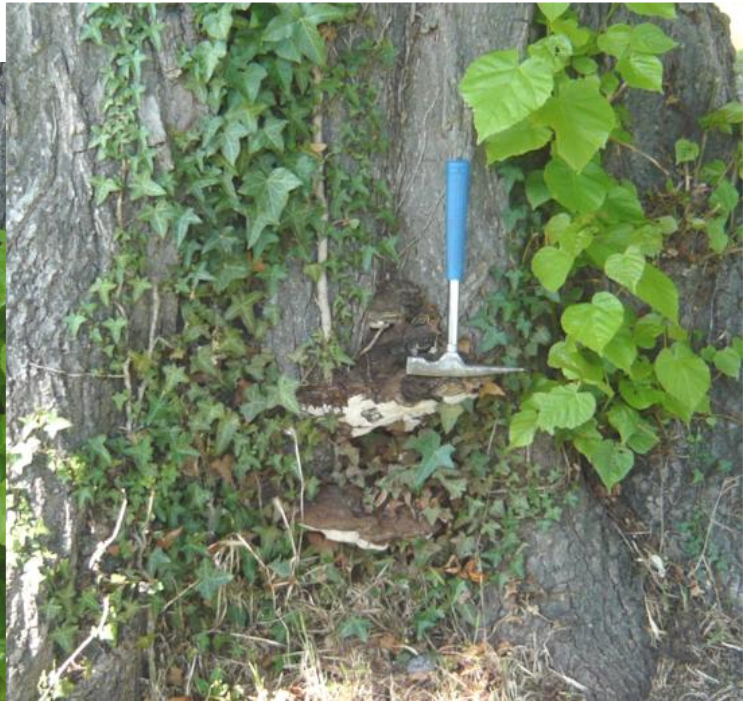
- 4.4 Two separate areas of *Ganoderma applanatum* spore bodies on base of lime T20, below.

| T20 | Common lime | 1180 | 23 | 2 | 12 | 8 | 8 | 8 | 8 | Lm | F | P | 40+ | Three <i>Ganoderma</i> bracket on south and west sides. Advanced basal decay. | A2 | 14.2 | Heavy crown reduction down to 15m and 1/3 off radii. |

- Big lime T20 which has basal decay, and we recommend crown reduction, has its theoretical RPA under existing and new building so no change.
- A very small part of T20's RPA is replaced by the extended carpark. This is insignificant loss: particularly if the tree is crown reduced. But we still recommend careful root pruning, see 6.6 below.

| T20 | Common lime | 14.2 | Heavy crown reduction down to 15m and<br>1/3 off radii. | <u>Crown reduce as recommended.</u> | <u>To allow for increased pedestrian access around the trees.</u> |

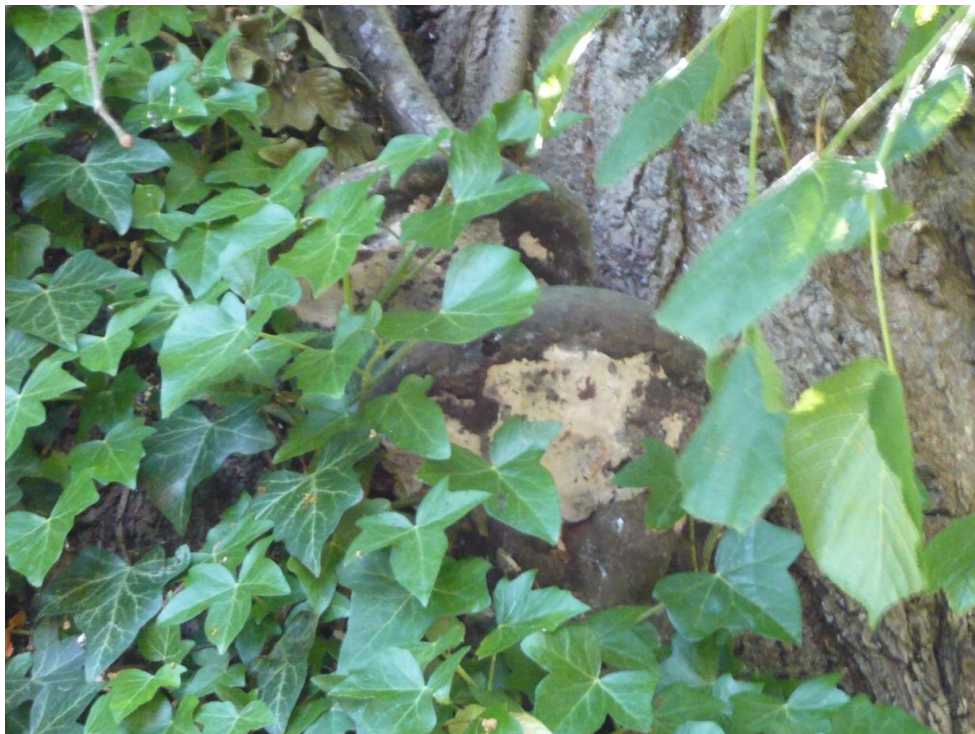
- 4.5 Below: two spore bodies of either *Rigidoporus ulmarius* or *Ganoderma resinaceum* decay fungi at 2.5m on lime T22.

| T22 | Common lime | 1120 | 24 | 2 | 12 | 8.5 | 9 | 8 | 8 | Lm | F | P | >40 | Hollowing base. Decay fungus at 2.5m. | A2 | 13.4 | Heavy crown reduction down to 15m and 1/3 off radii. |

| T22 | Common lime | 13.4 | Heavy crown reduction down to 15m and<br>1/3 off radii. | <u>Crown reduce as recommended.</u> | <u>To allow for increased pedestrian access around the trees.</u> |

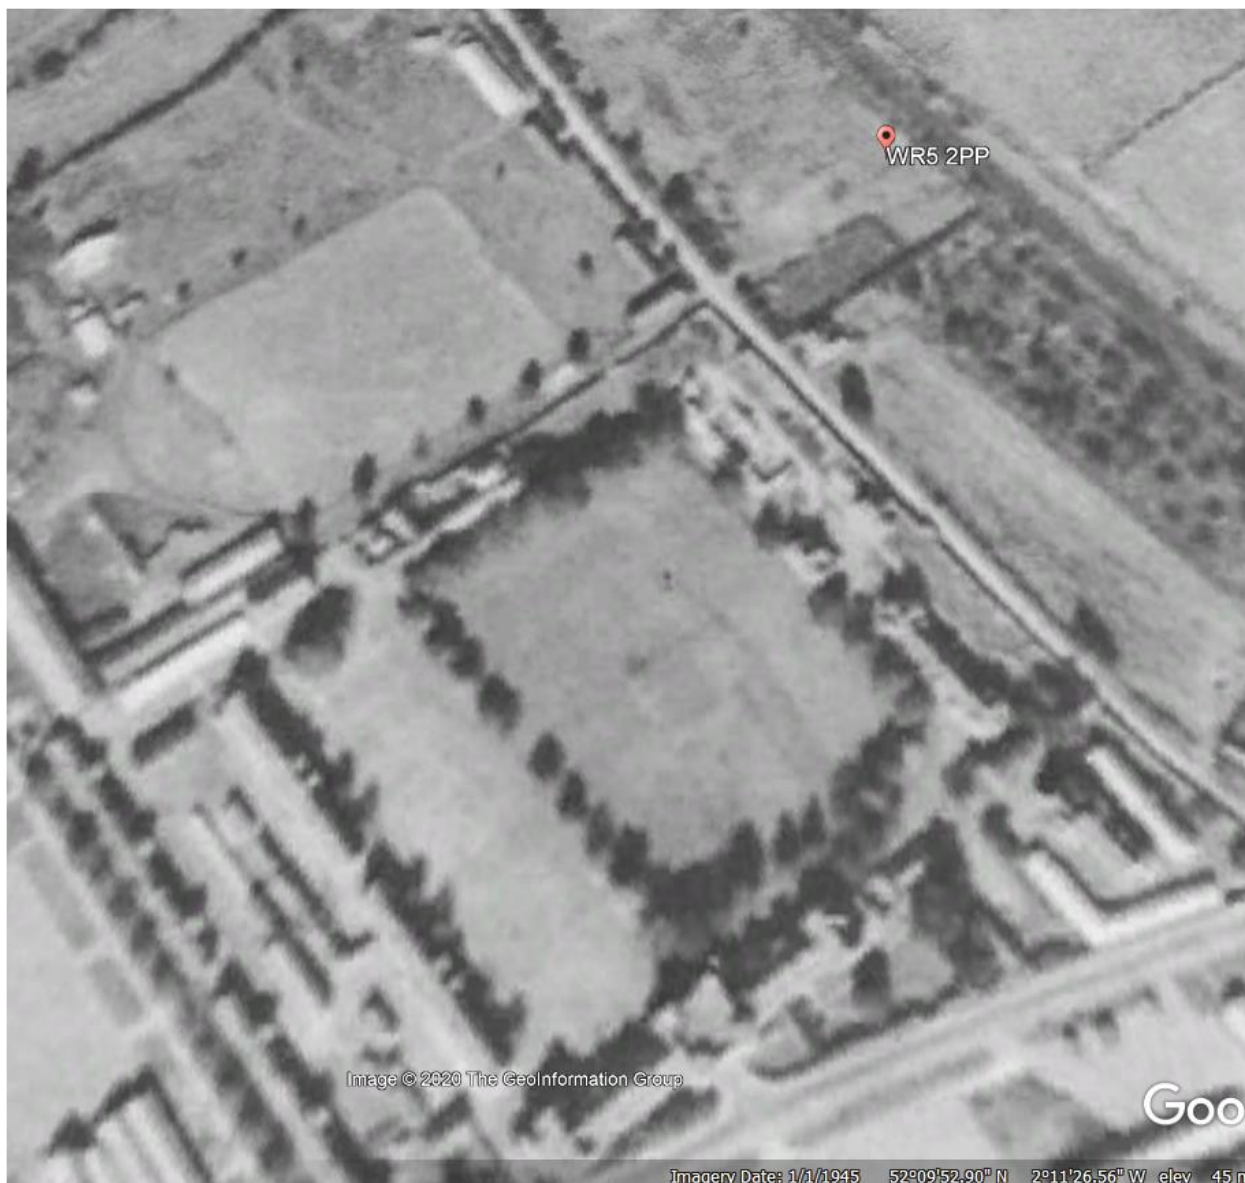
- 4.6 1945 aerial shows many more limes, but the four current limes opposite the clubhouse were big trees even 75 years ago.

- 4.7 These four old limes, which have the highest level of access nearby, need attention. They could be given ultrasound tests to measure basal soundness or decay, after which some or all could be pruned. Or they could be crown reduced.
- 4.8 Our advice would be to crown reduce all four, to retain them as similar-sized trees and to maintain their collective landscape value. We understand there are plans to re-build the clubhouse etc, which will impact these trees. (For this reason we have included BS5837 pre-development tree information in our tree table below).
- 4.9 We strongly recommend that ALL limes on site have epicormic growth removed annually, tight back to the wood of the trunk. Once done by chainsaw, it can be repeated annually with a hedge trimmer.
