# BUILT HERITAGE STATEMENT

Norton Cricket Club Clubhouse, Worcester

JCH01259  
Built Heritage Statement  
v.1.1  
11 December 2020

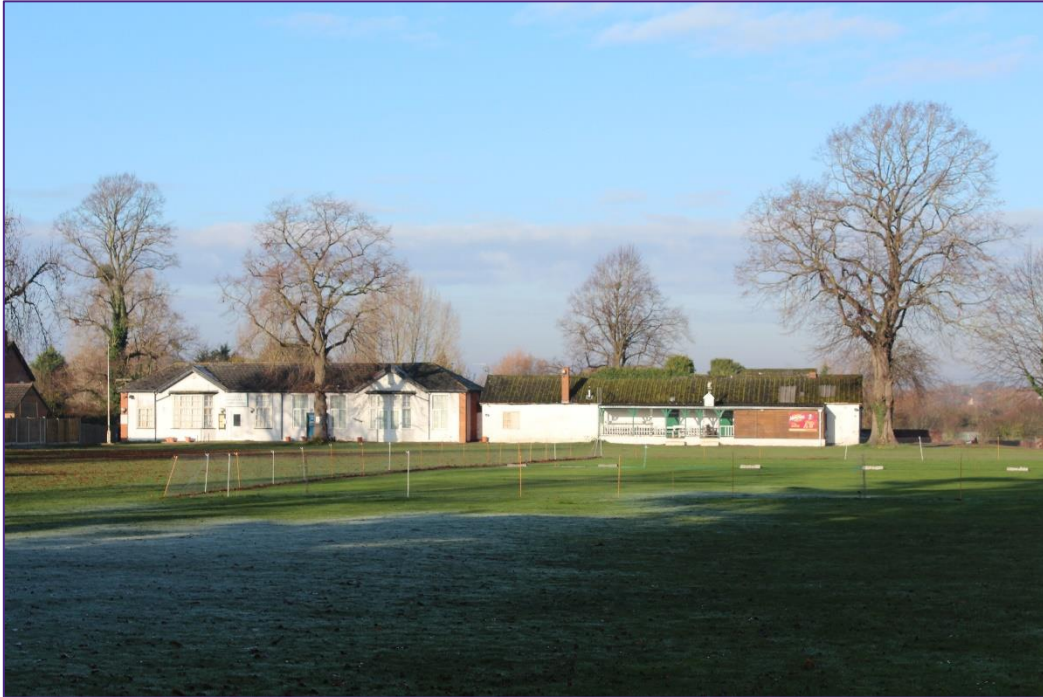
- 3.18 The Site (Plates 1-6) comprises the two-storey Norton Cricket Club Clubhouse, dating from the early twentieth century with a poor quality mid-twentieth century later single-storey brick extension to the east serving as changing rooms. It also includes the former tennis court. The Clubhouse has two projecting rear wings connecting to a link detached small single-storey building (now the boiler house) which may pre-date the main clubhouse building. The rear of the Clubhouse and changing rooms also have areas of soft and hard landscaping; all overgrown and in poor condition. The Site is contained by remnants of a much broken and altered perimeter wall on its northern edge.

Plate 1: The Clubhouse with later changing rooms (the 'Site') added to right hand side viewed south from sportsground

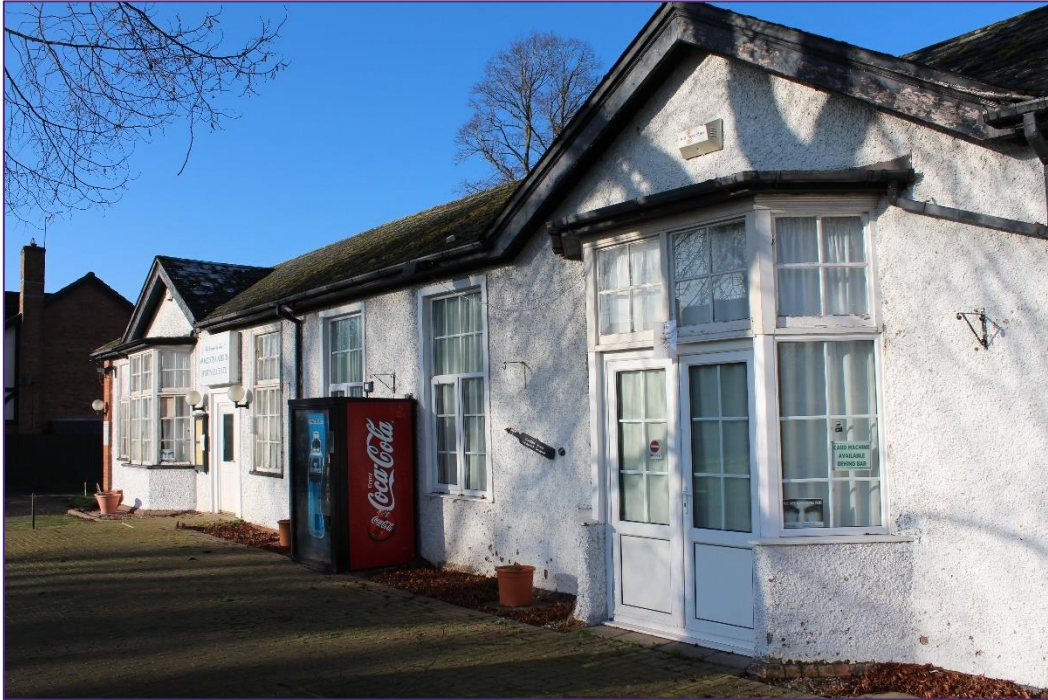
Plate 7: Front elevation of Clubhouse with evidence of later PVC windows.

- 3.41 The windows and architraving appear to have been replaced on an *ad hoc* basis with poor quality PVCu substitutes which have materially impacted the significance of the building and how the building is read. These later windows/doors have very much unbalanced the fenestration. This is

- Existing blown masonry below the damp proof course is to be replaced with bricks to match colour, and repointed. Note it is considered that there is any lime mortar used in the bedding of brickwork on this building;
- All later PVCu windows and architraving will be replaced with new timber double glazed units that will match the existing original windows. Timber architraving, framing and cills will also be replaced like-for-like if they are not salvageable.

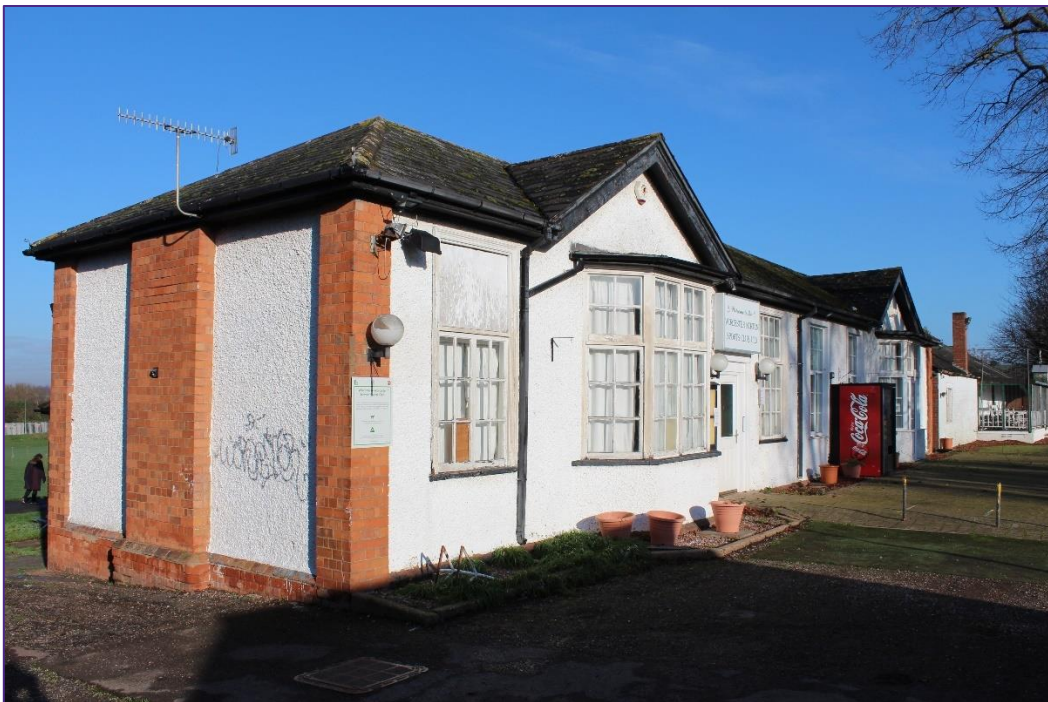
Plate 8: View east over Clubhouse with evidence of chimney breast noted on end flank.

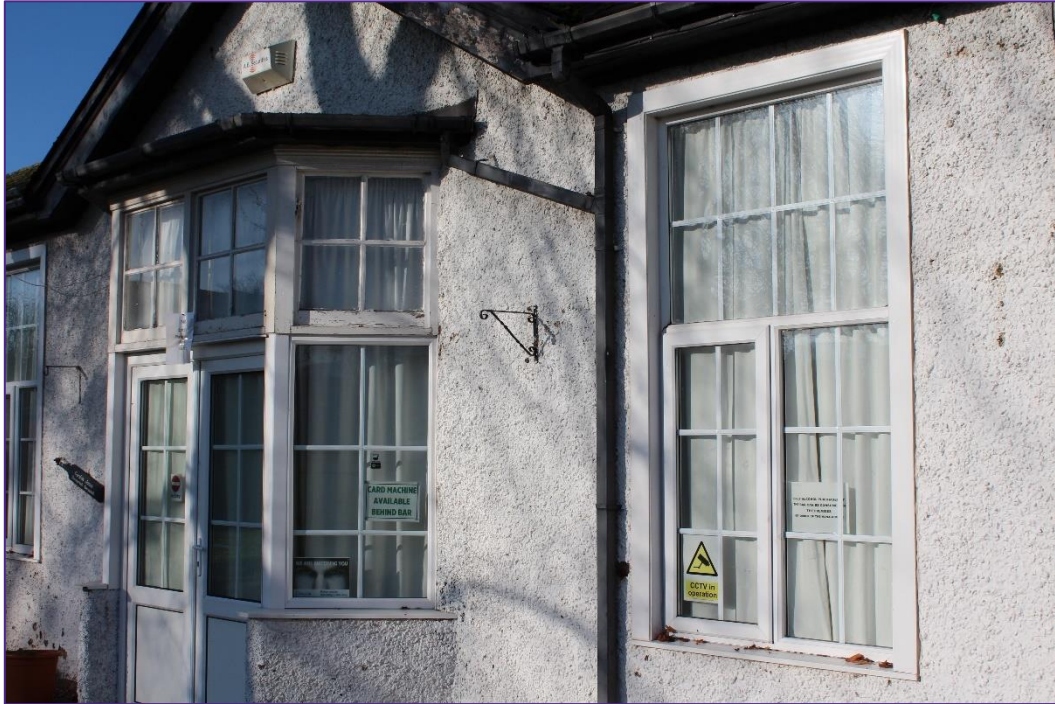
Plate 9: Use of PVCu on Clubhouse including creating new doors into bay window.

exacerbated by later glazed doors inserted into one of the bay windows. The remaining original simple timber windows; comprising two six-pane casements and a top hung casement of eight panes above, are generally in a poor condition, including peeling paint, rot, broken panes and evidence of boarding up. The awkward juxtaposition is particularly evident on the bay windows where the replacement of original timber casements with PVCu inserts within the timber bays look awkward and ill-fitting. The bay window frames are still original however, as is the original cornicing set atop each bay. The front door to the Clubhouse appears to have had disproportionately wide PVCu architraving of no design quality fitted alongside an equivalent poor-quality door which very much alters the appearance and balance of the frontage. This architraving may simply be covering further architraving behind given that it still remains internally. It may be that the wider architraving was fitted to facilitate a narrower standard-sized door. A large club sign above the front door covers what would have been a further top hung timber casement. This also still exists behind.

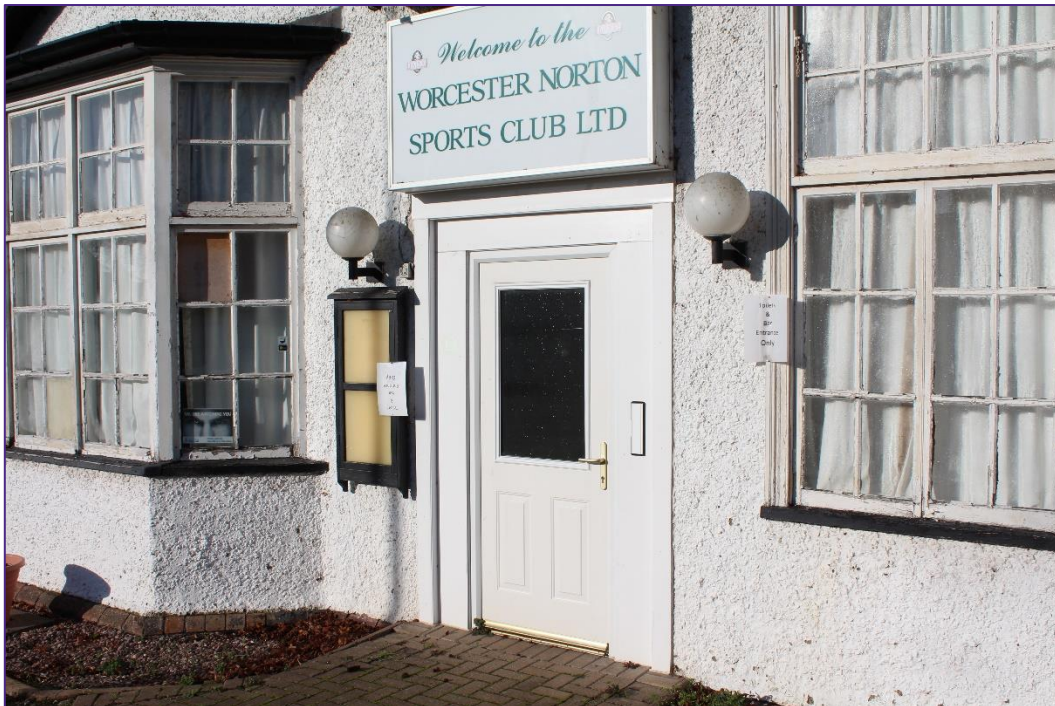
Plate 10: Later front door with heavy PVCu architraving and signage concealing original top hung casement window.

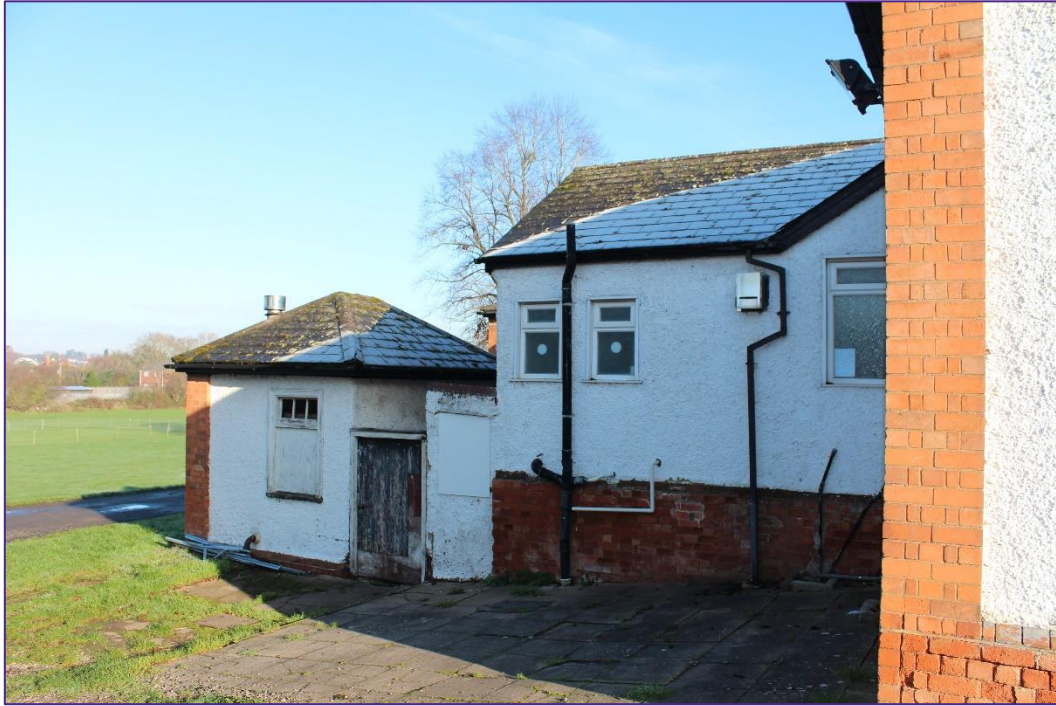
- 3.38 The building has suffered prolonged deterioration and structural failure in recent years, in part likely on account of the nature and simplicity of its construction. This includes damp, water ingress and blown bricks resulting from extensive use of cement mortar and poor-quality bricks. The building is in need of structural repair.

Plate 11: The west flank of the Clubhouse with earlier link-detached building noted (left). Evidence of blown brick noted on rear wing by rainwater goods.

- 4.7 The sensitive repair/replacement of bricks will not only structurally secure the building, but it will improve its overall appearance, as will the repair of the existing cement render where required.

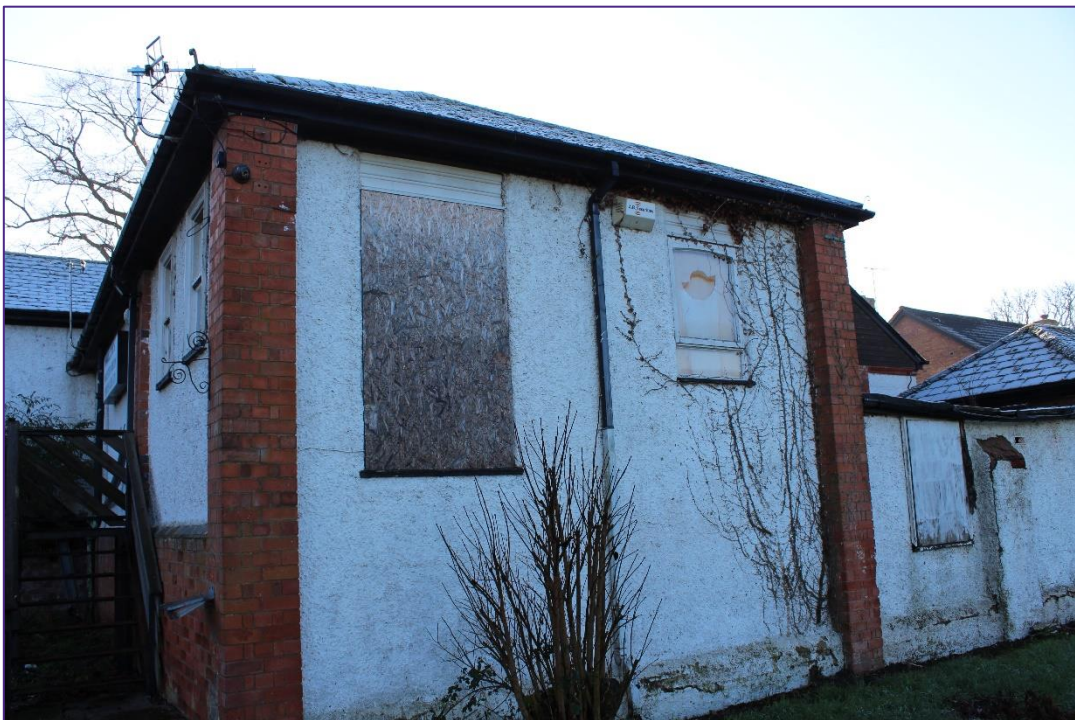
Plate 12: Boarded up windows on north flank of Clubhouse rear wing and later fire escape and staircase (left).

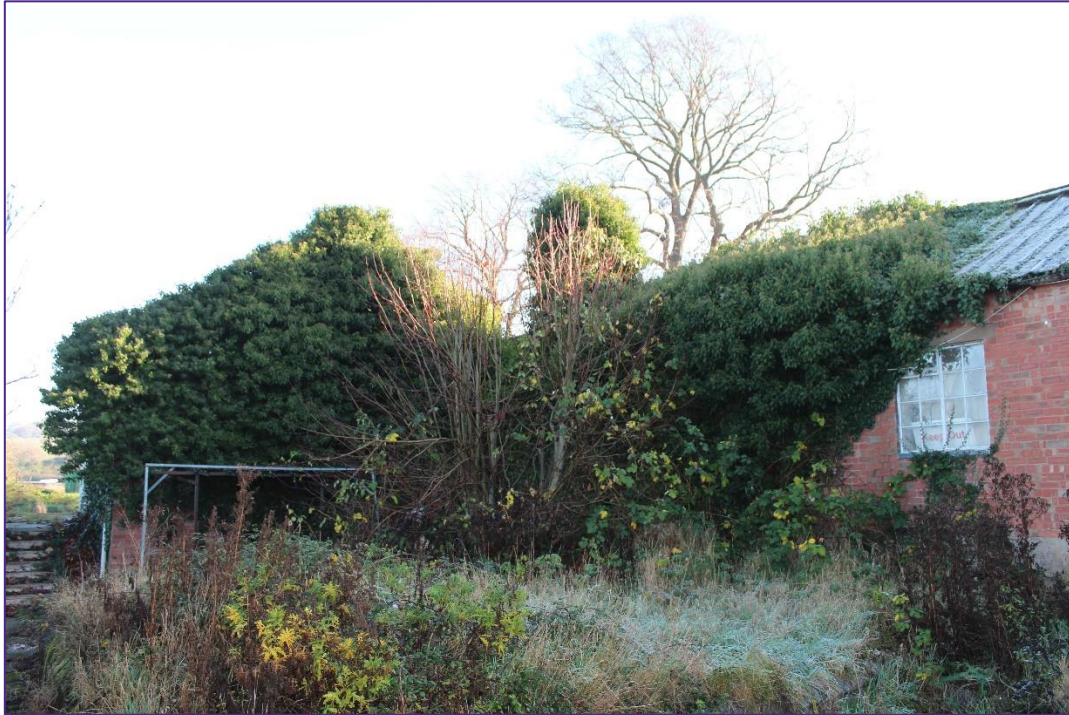
- 3.49 The small extent of open space to the rear of the changing rooms, laid to patios and soft landscaping is overgrown and in poor condition. Access is granted to the rear via a path running the length of the former barrack perimeter wall. This wall, falling within the Site is now largely reduced, altered and/or removed in most places. It is therefore difficult to appreciate this structure as being the original perimeter wall, the presence of later sports facilities north of the Clubhouse further lessen any contribution the remaining wall makes, suggesting that the wall now exists only as a means of enclosure to the Clubhouse.

Plate 13: Heavy unmanaged vegetation growth over changing room extension.

- 4.6 The changes to the Clubhouse external appearance represent an enhancement to the significance of the asset and improve its legibility. Specifically, the demolition of the mid-twentieth century changing room extension which is considered to be a detrimental visual feature which detracts from the overall significance of the Clubhouse. The removal of the later very poor quality PVCu windows, doors and architraving, to be replaced by like-for-like timber equivalents to match those original windows and doors which remain is also an enhancement;

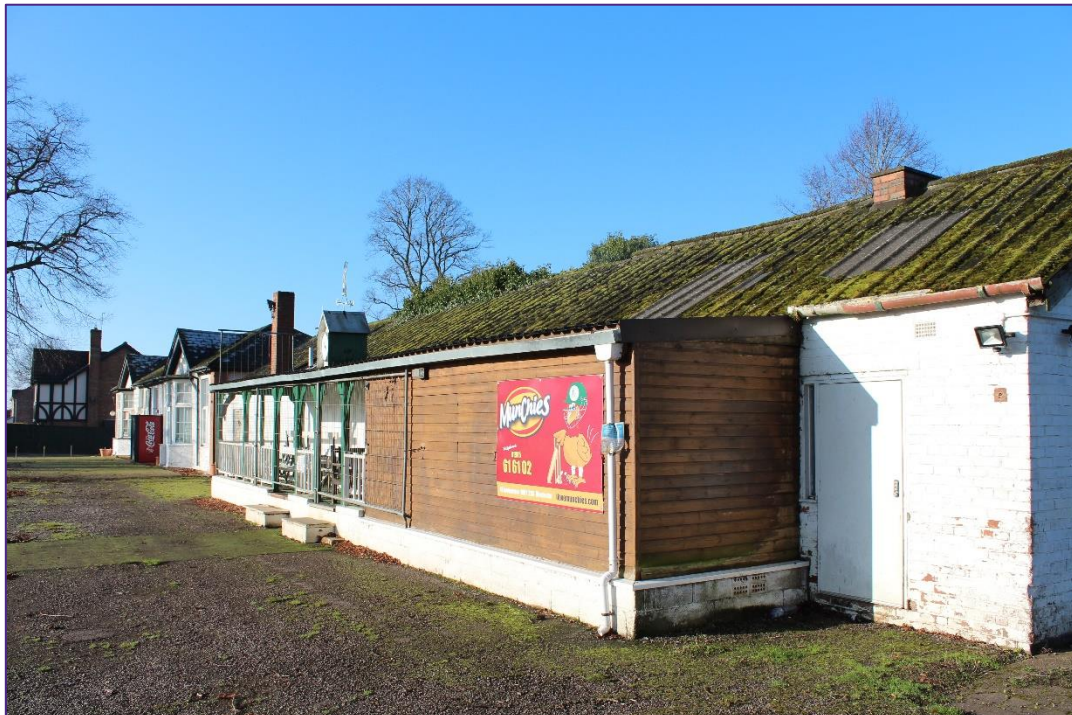
- 3.47 The later changing rooms have very limited architectural merit; the exception being a timber veranda for access into changing rooms and team seating overlooking the cricket pitches. It also has an eave-height clock and weathervane, which appear in poor condition. These limited features create some visual interest to the south facing facade. The building has extensive unmanaged scrub covering much of the rear façade. There are very few windows, limited to the rear only, and of no architectural interest.

Plate 14: Front elevation of changing room extension.

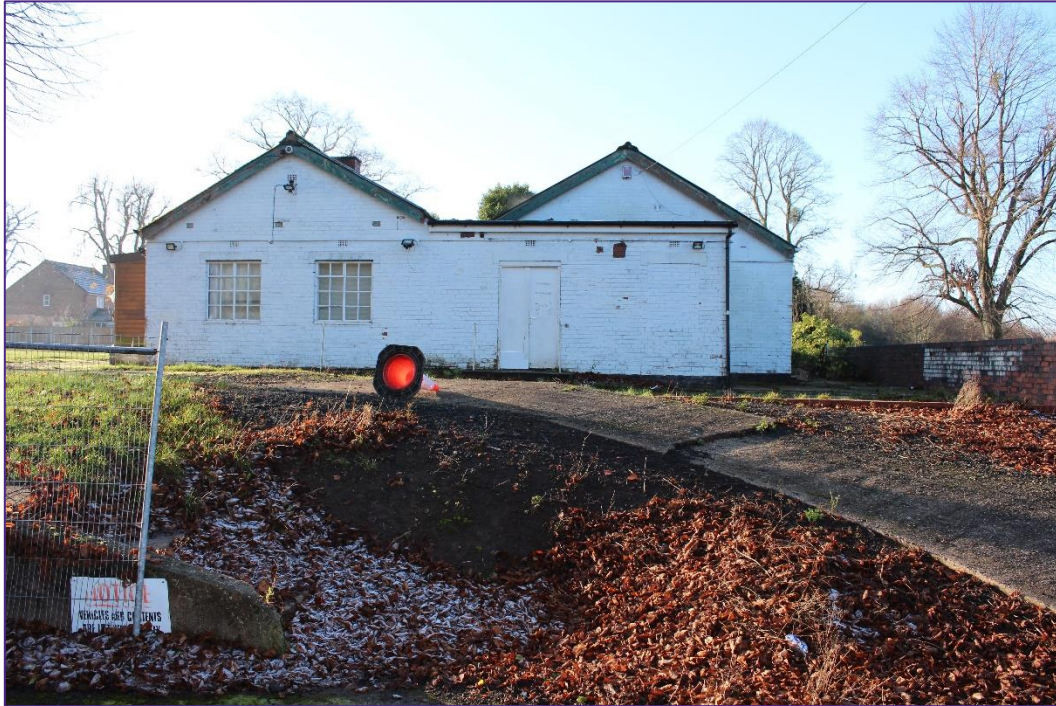
Plate 15: East gable ends of changing room extension viewed from car park.

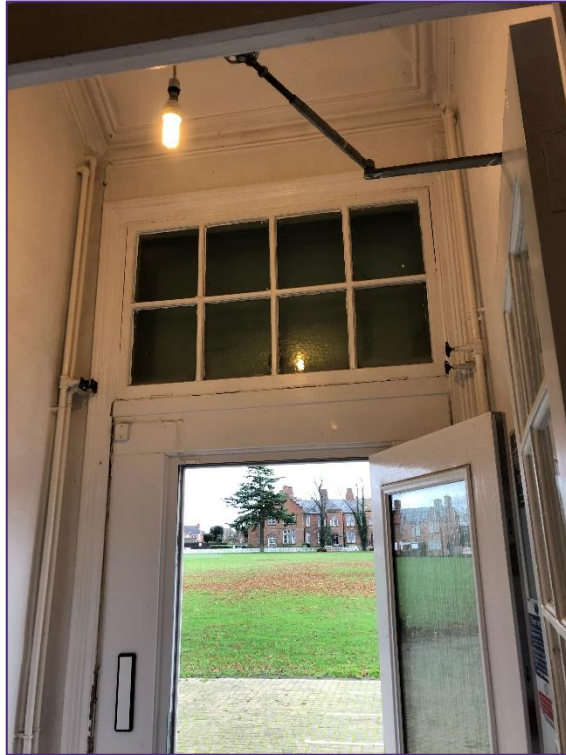
Plate 17: Original front door architraving seemingly infilled with later PVCu door casing and smaller door. Blocked off glazing above (Photo courtesy of Greenwood Projects).

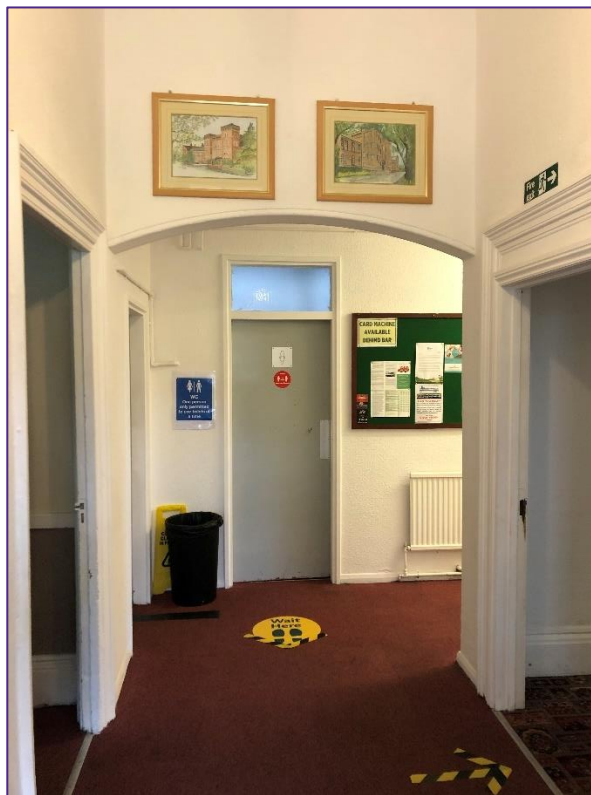
Plate 18: The hall with original doorways and architraving leading off and original shallow arch at end (Photo courtesy of Greenwood Projects).

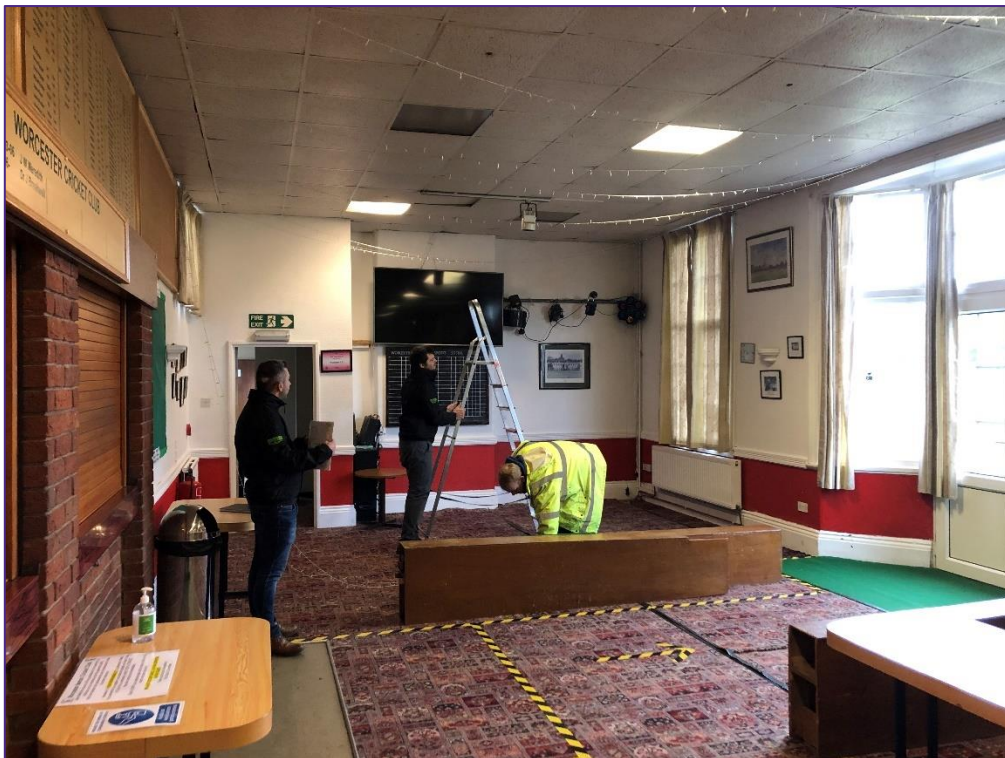
Plate 20: The righthand room with further boarded up fireplace, bay windows serving as doors and the entrance into the later changing rooms (rear left). Later serving hatch noted left (Photo courtesy of Greenwood Projects).

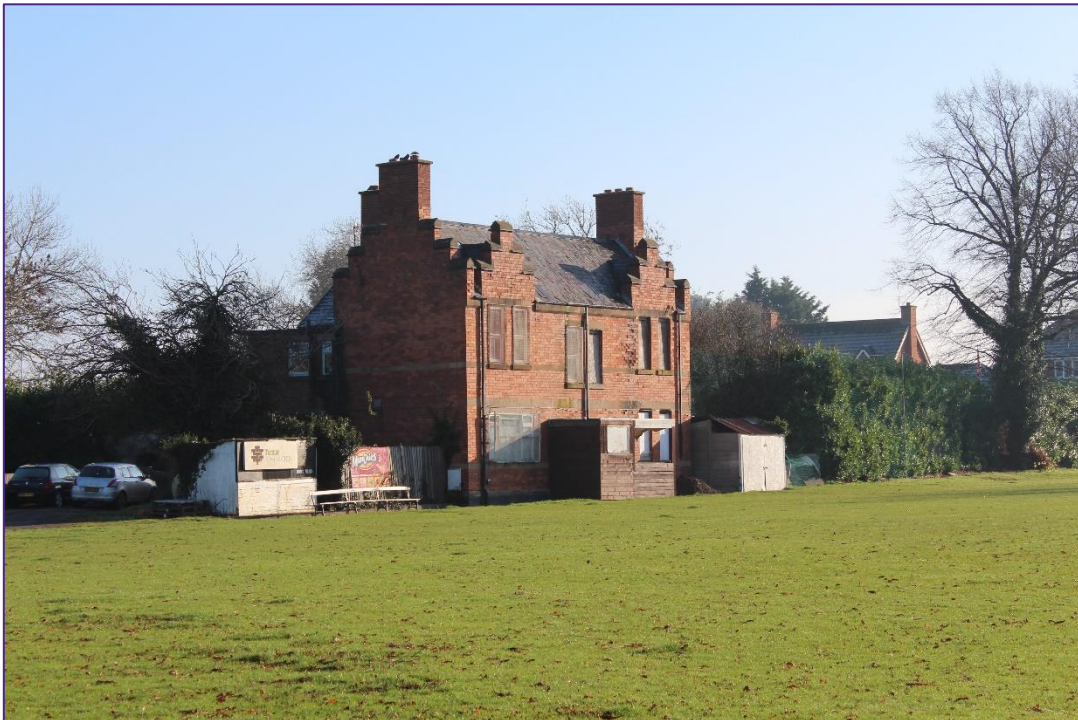
- 3.77 **Significance:** The Stewards' Houses were understood to have been built in the early twentieth century (Jobson, S in *The Story of Norton Barracks* p xii). Historic mapping shows that they existed by 1904. The semi-detached pair of dwellings are understood to have served as mess blocks and formed a part of the barracks. Any further information on the former role of the buildings could not be found at the time of writing. They do, however, occupy a prominent position overlooking the sports ground and, at one time, were symmetrically flanked by two large detached barrack blocks on either side. Later flat roof extensions are seen to the rear as well as smaller additions to the front, associated with the cricket facilities. Whilst one dwelling is occupied the adjacent property is empty and the dwellings are in a poor state of repair with blown brickwork and slipping slates on the roof.

Plate 26: The Stewards' Houses viewed from edge of Site with later extensions noted to rear.
