27 November 2020

**Preliminary Roost Assessment – Worcester Norton Sports Club, Brockhill Lane,  
Norton Barracks, Worcester, WR5 2PP**

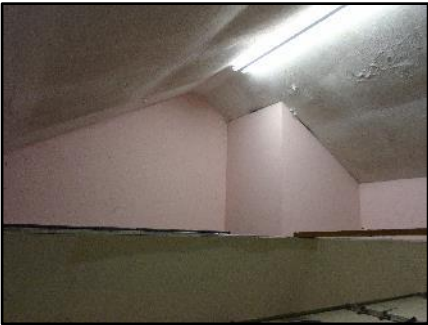
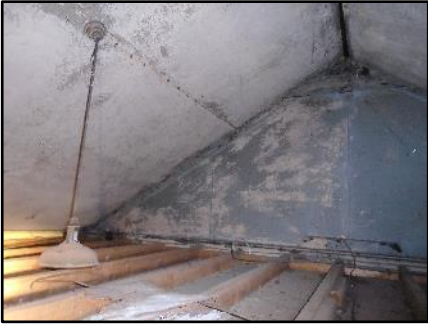
| | <p><u>Internal Description:</u></p> <p>There is a small loft located along the eastern side of the building and false ceilings to the west of the structure with rooms open to the apex of the building.</p> <p>The roof void above the false ceiling is approximately 1.6m in height from ceiling tiles to the roof apex. The loft space on the eastern end of the building is not insulated and lined with wood-fibre boards.</p> <p>The entire loft space was heavily covered with cobwebs with signs of mould. No evidence of roosting bats was found.</p> <div style="display: flex; justify-content: space-around; align-items: flex-end;"> <div style="text-align: center;"> <p><b>Plate 9:</b> typical view of the space above the false ceiling.</p> </div> <div style="text-align: center;"> <p><b>Plate 10:</b> loft void of the changing rooms.</p> </div> </div> |

There is no evidence to suggest that the ‘changing rooms’ building supports roosting bats. No signs of bat roosting activity (e.g. bat droppings, feeding remains, urine stains etc.) were

observed during the survey within the loft and areas above the false ceiling of the building and the exterior of the building is in good state of repair and tightly-sealed.
