Ref: 15<sup>th</sup> Dec 2020 - BJU/mmi

To: **Worcester Norton Sports Club.**

**Norton Barracks, Brockhill Lane, Norton, WR5 2PP.- BS5837 Tree Constraints, Tree Impacts and Tree Protection Method Statement for replacement Community Hall & Pavilion.**

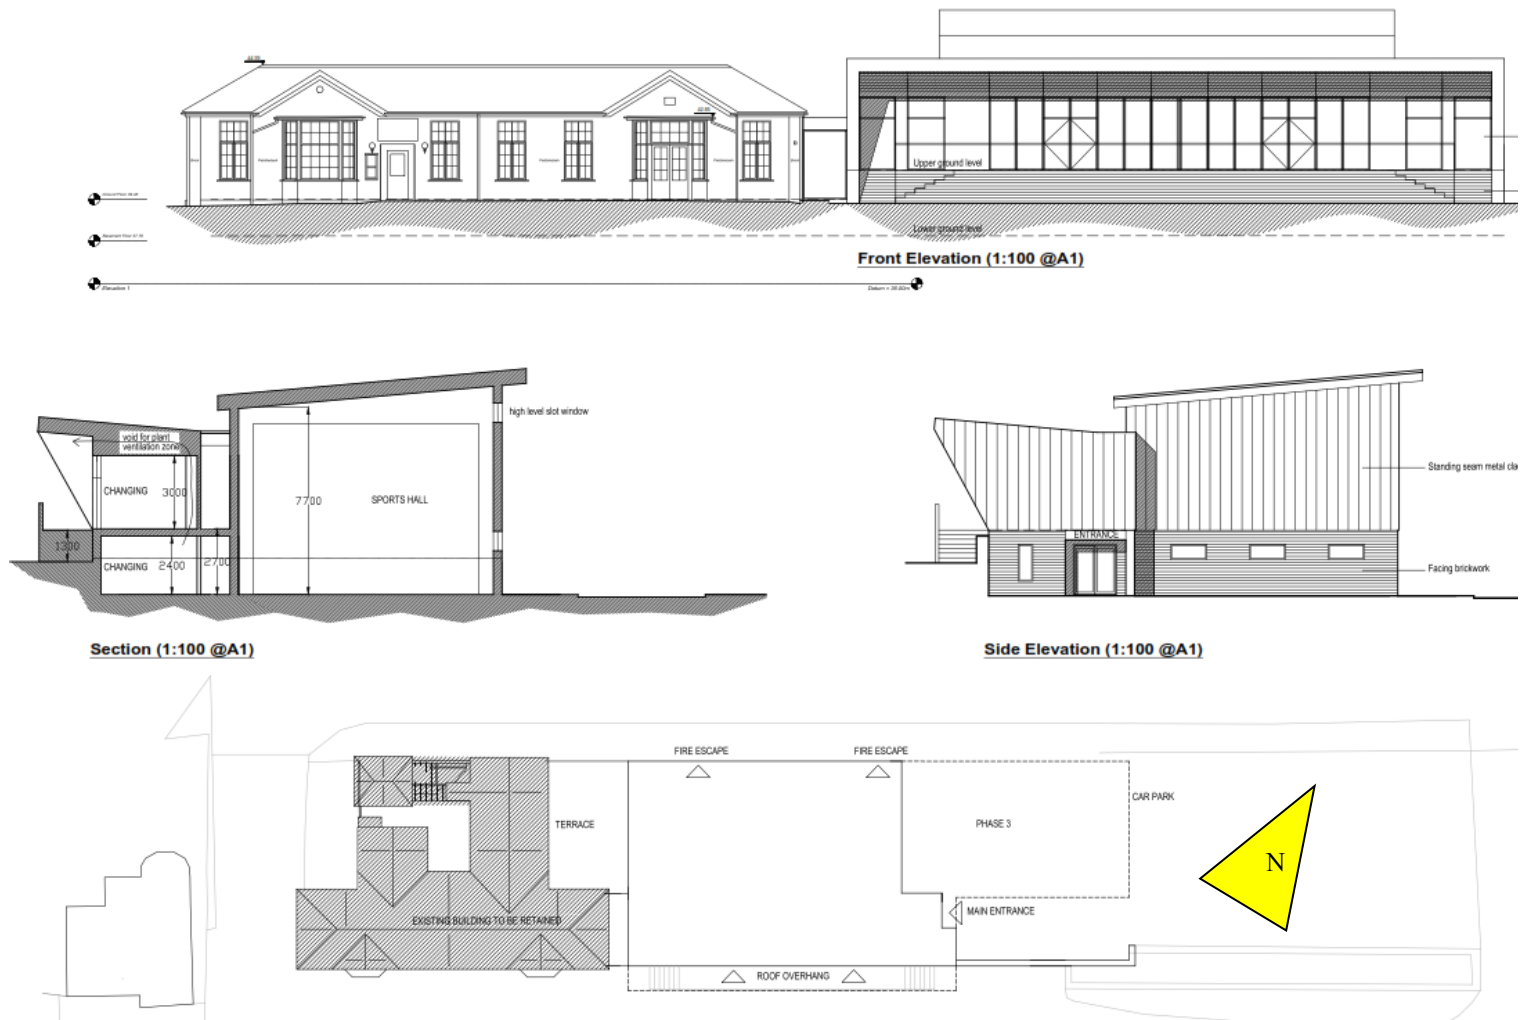
- 5.1.1 The plan, **Boughton Butler Site Plan sections etc No.12 dated 20/10/20**, extract below, shows the proposal. Tree retention is indicative.
- 5.1.2 One existing building is replaced by a larger building.
- 5.1.3 The parking area to the north east is extended to the edge of the new building.
